# Inspection Report

123 Austin Park  
Autin TX 78645

## PROPERTY INSPECTION REPORT

Report Identification 123 Austin Park

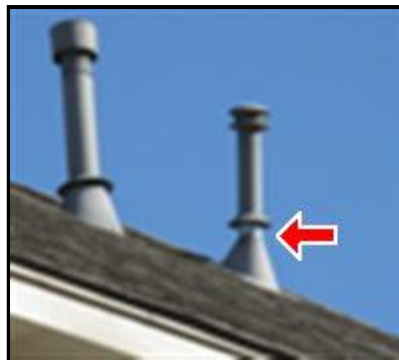
C. Picture 1

The 'rain collar' on the right rear water heater vent pipe is not positioned properly and may allow water penetration. The collar needs to be moved downward and sealed near the pipe boot jack joint.

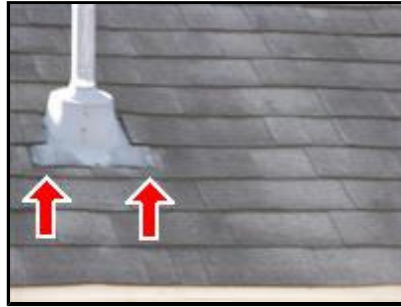
Seal all exposed roofing fasteners in various locations (i.e. plumbing vents, flue pipe roof jacks, flashings, and ridges lines.)

C. Picture 2 Example of roof fasteners

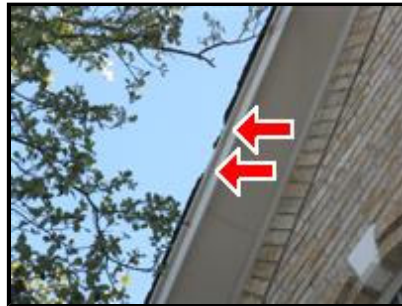
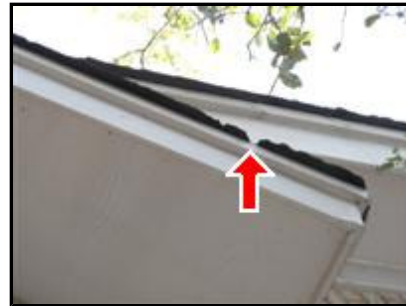
Roof edge shingles have been damaged on the front of the home in several locations, most notably on the left side of the main peak and on the "eyebrow" roof on the lower left corner. Repairs are needed to prevent water damage to wood components below.

C. Picture 3 Left front of home

C. Picture 4 Lower left roof corner

C. Picture 5 Left front corner damage

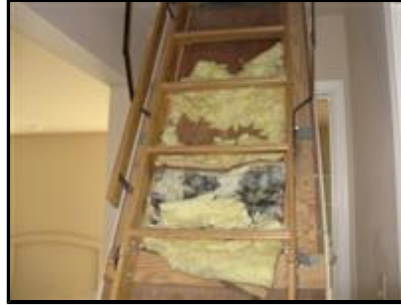
D. Picture 1

Attic access stair door needs to be properly insulated to improve energy efficiency as is now the standard.

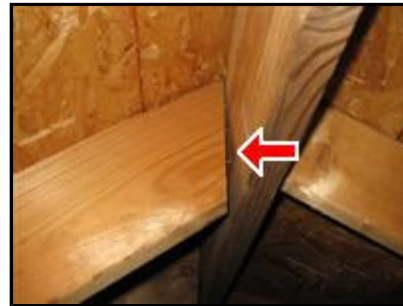
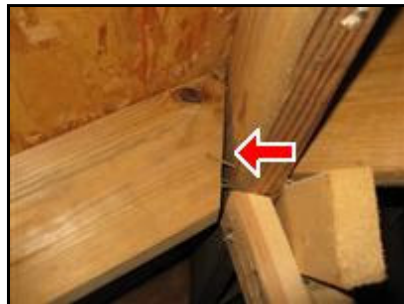
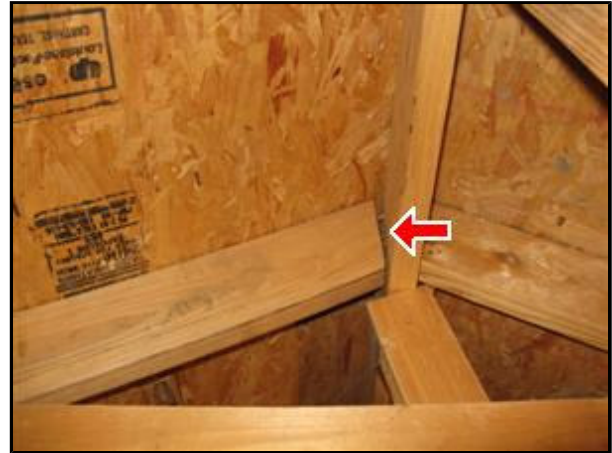
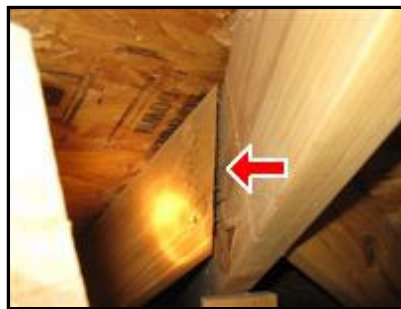
Several roof rafters have somewhat poor connections to the ridge beams that they are attached to. This was most notably seen at the left front roof peak and near the attic access opening of the home. Recommend further evaluation by reputable contractor to augment or support these connections more satisfactorily where there are gaps that have been spanned with nails.

D. Picture 3 Left front of home

D. Picture 4 Left front rafter gap

D. Picture 5 Left front of home

D. Picture 6 Right rear of home

D. Picture 7 Right rear of home

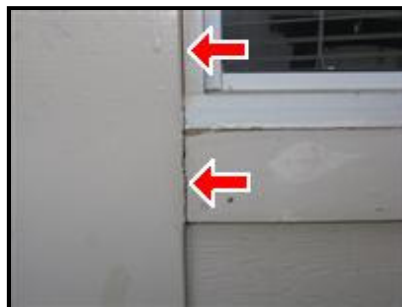
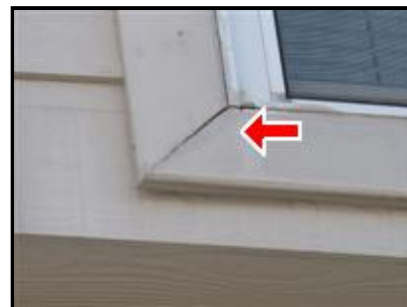
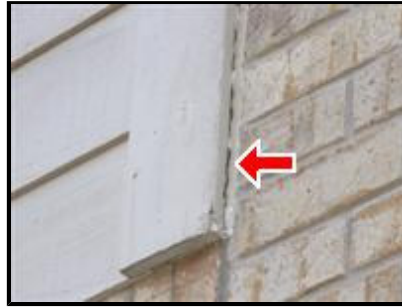
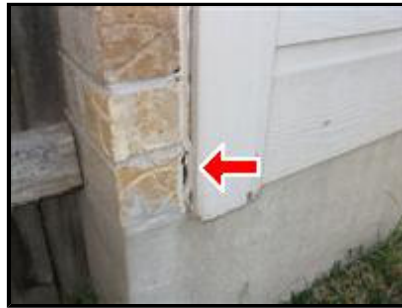
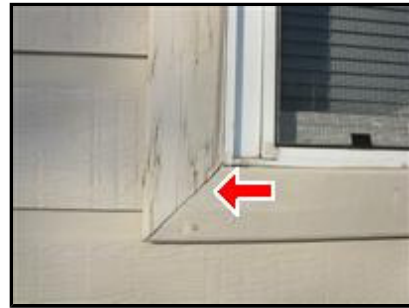
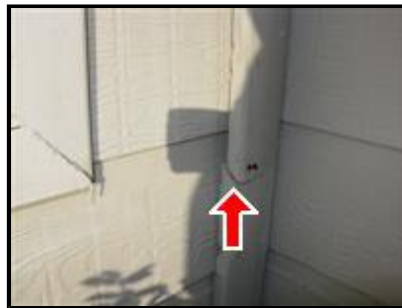
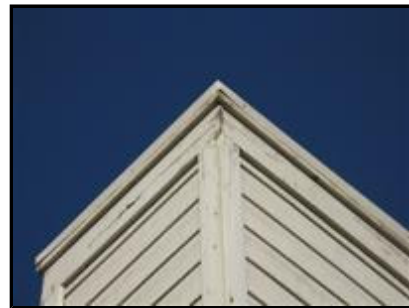
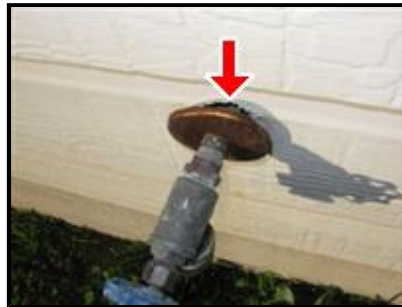
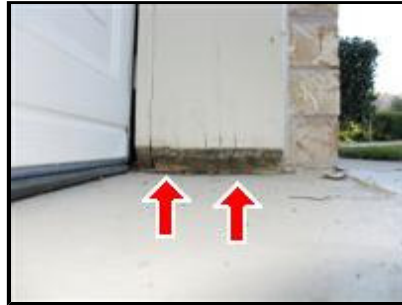
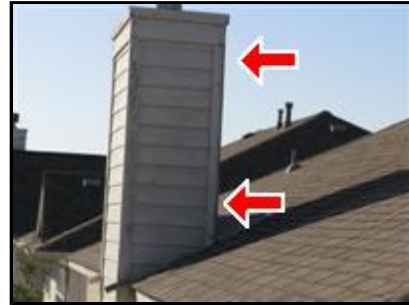
Seal all areas on exterior of home to prevent water damage to unprotected wood, most notably: pipe penetration openings, seams in trim and siding, around window frames and any bare wood.

E. Picture 1 Front porch window frames

E. Picture 2 Rear upper story window

E. Picture 3 Rear of home

E. Picture 4 Siding gaps on right side

E. Picture 5 Right rear corner trim

E. Picture 6 Lower rear bedroom window

E. Picture 7 Trim beside chimney

E. Picture 8 Weathered chimney trim

E. Picture 9 Back hose bib

E. Picture 10 Back door trim damage needs sealing

E. Picture 11 Garage trim needs sealing

E. Picture 12 Weathered trim needs sealing

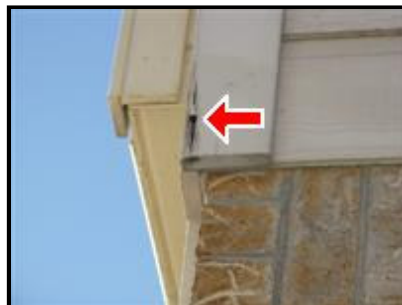
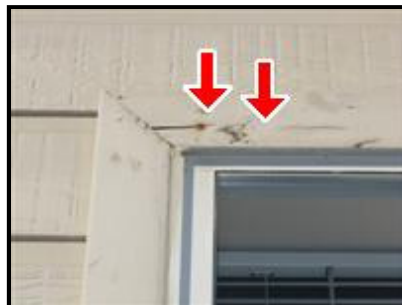
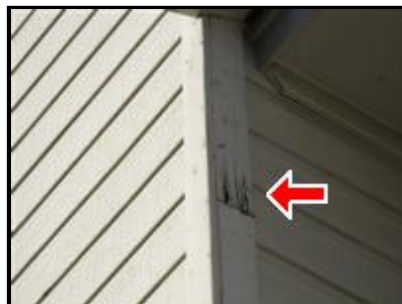
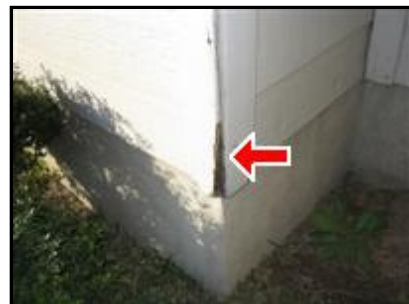
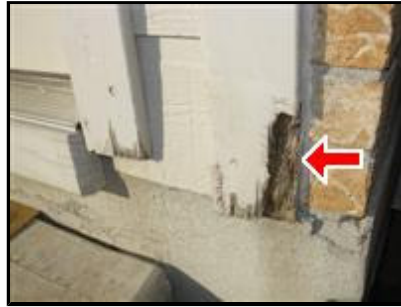
Damaged and water softened around home needs to be repaired or sealed to prevent further deterioration.

E. Picture 13 Left rear corner of upper story

E. Picture 14 Bottom edge of garage door, left side

E. Picture 15 Rear window beside fireplace

E. Picture 16 Rear window beside chimney

E. Picture 17 Chimney trim below upper roofline

E. Picture 18 Lower edge of chimney

E. Picture 19 Left rear corner trim

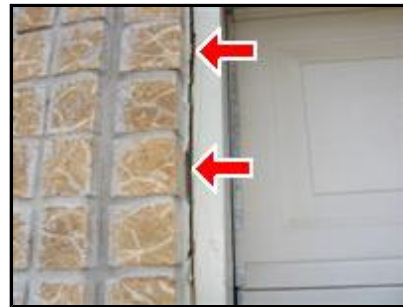
The left side garage door trim on the right door is damaged where it has been impacted and pulled slightly away from the brickwork. The trim along the back has broken off and leaves a gap between the door and trimwork. Recommend repair or at least sealing to prevent water damage.

E. Picture 20 Damage to garage door trim

E. Picture 21 Gap between brickwork

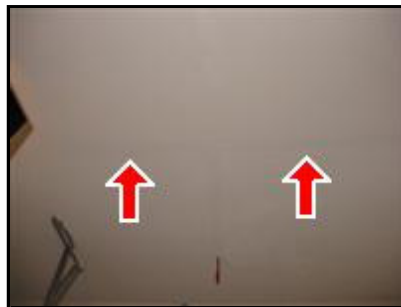
The ceiling in the garage has a water stain on a sheetrock joint from unknown previous moisture. There was no current moisture present as monitored by electronic moisture meter and any continuing leakage would damage the sheetrock. I believe that this staining is likely from an overflow event in the bathroom or laundry room above.

F. Picture 1 Slight water staining

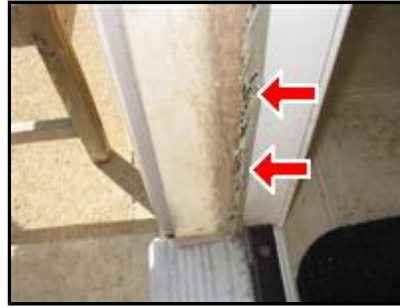
Back door has damaged weather-stripping due to pet activity, but the door does not

appear to be allowing air intrusion.

G. Picture 1 Damaged weatherstripping

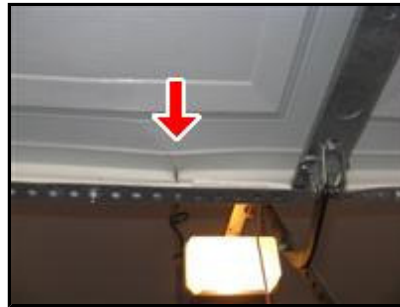
G. Picture 2

Garage doors have had previous damage to the top edge and have been repaired and strengthened to maintain satisfactory operation.

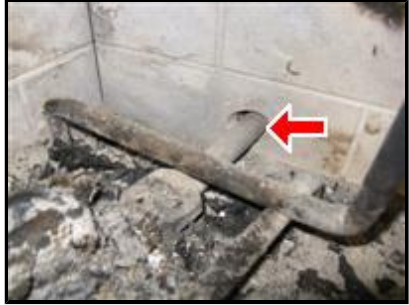
J. Picture 1

Seal opening around log lighter pipe to prevent excessive heat escape into wall void. Recommend caulking with an available fire-proof material.

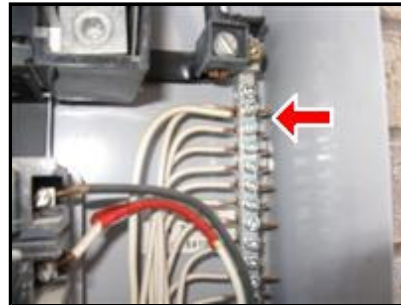
A. Picture 1 Electrical panel

Neutral wires (white) are not individually secured to the busbar at the sub panel as required to meet current standards. This is very commonly seen and is typically as simple as moving wires within panel by a licensed electrician.

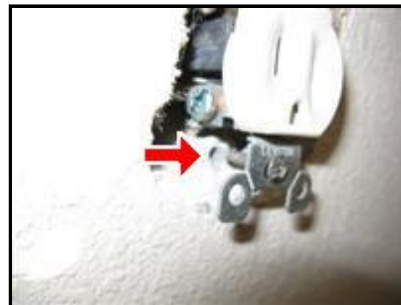
Electrical outlet on the left rear wall of living room is loose in wall and the screw is stripped out. The bottom half of the outlet is also not "hot" and needs to be repaired by licensed electrician. (half wall near back door)

B. Picture 1 Screw stripped

Electrical outlet on the left rear wall of living room is loose in wall and the screw is stripped out. The bottom half of the outlet is also not "hot" and needs to be repaired by licensed electrician. (half wall near back door)
-

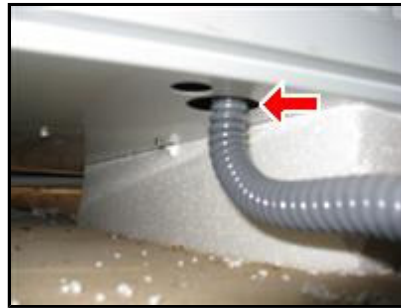
Modern standards require rigid piping where gas supply enters HVAC housing to prevent rubbing and potential for causing a leak. (these units are not as likely to be a concern due to the close proximity of the gas connection inside)

A. Picture 1 Furnace gas pipe

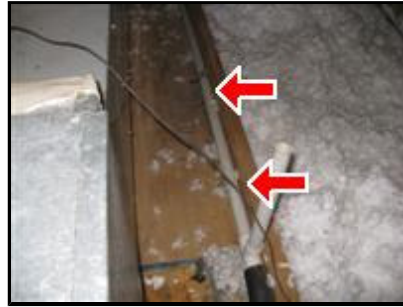
Recommend insulating the a/c primary condensation drainlines as is now the standard.

B. Picture 2 A/C condensation line

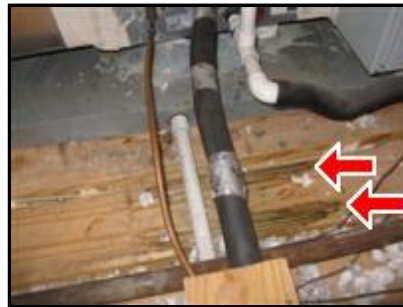
Water stains on attic flooring appears to be from the a/c freon line condensation where there is a seam in the bottom that is allowing water to drip out and onto the flooring below. Recommend better sealing this insulation to prevent humid air from reaching it.

B. Picture 3 Black insulation needs repair

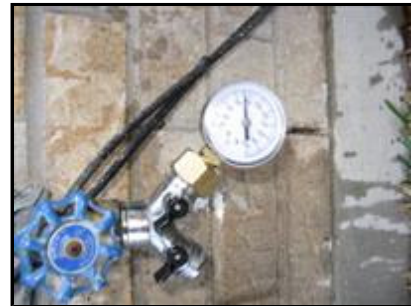
Water pressure was checked and found to be approx. 70 PSI which is within acceptable ranges. (excessive pressure can be damaging to pipes)

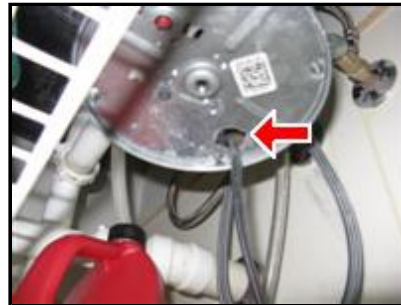
B. Picture 1

The food disposer wiring is missing a romex connector (anti-strain device) where wiring enters bottom of unit. Repairs recommended.
