# Inspection Report

123 Austin Park  
Autin TX 78645

## PROPERTY INSPECTION REPORT

Report Identification 123 Austin Park

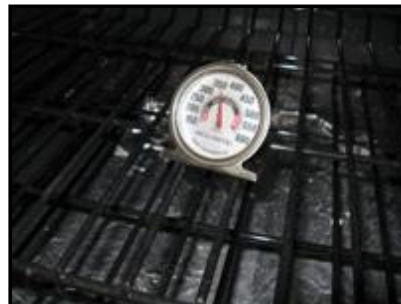
D. Picture 1

The oven was tested using the standard test and was within 5 degrees of 350 degrees setting which is considered satisfactory.
